**Flood Control Project Maintenance
Levee Inspections**

Maintenance Issue Types Only, Levee Inspection Report By Mile - Spring 2015

Sutter Maintenance Yard Maintenance Area 0016

Waterway	Bank	Unit Miles	Inspection Start/End	Inspector
Unit No. 01 Feather River	Right	4.06	05/05/2015 05/05/2015	Michael Pitta

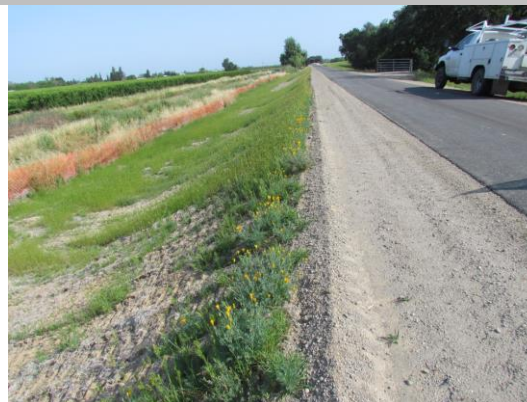
Photo 1 of 1 : SP_2015_MA0016_302_16_20150505_00009.jpg

LM Start	0.26	Rating **	A/W	Issue No.	16
LM End	3.19	Issue Type +	Ma	Location *	LS
Category	Earthen Levee			GPS Latitude/Longitude	
				Start	End
Item	Vegetation			39.259598 °	39.298393 °
				-121.636628 °	-121.638324 °
DWR ID	DWR_MA0016_01_s_2015_16				
Action/Comments					
Control annual grass and weeds on the levee slopes and easements.

This view of the vegetation was taken on the landside facing upstream
